FINAL REPORT

Corrosion Protection Mechanisms of Rare-Earth Compounds Based on Cerium and Praseodymium

SERDP Project WP-1618

APRIL 2012

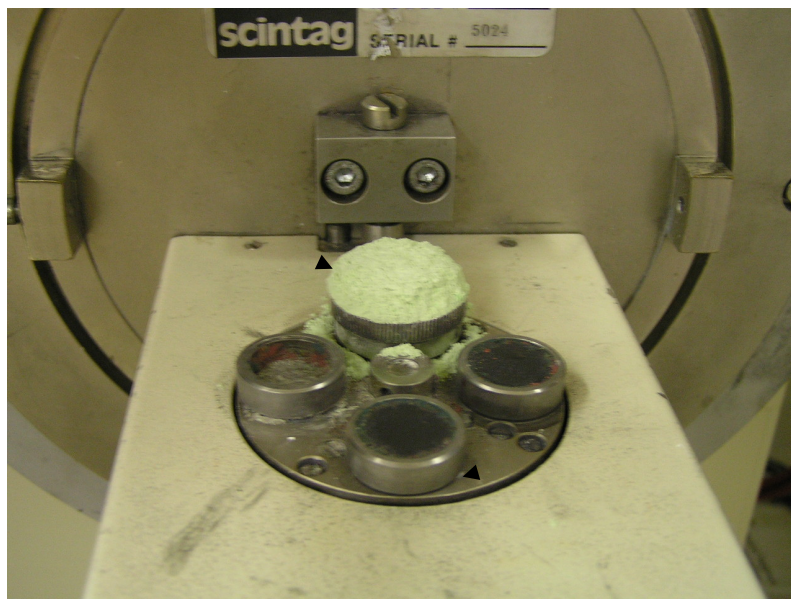
Figure 6. Pr_2O_3 and Pr_6O_{11} following eight hours of XRD analysis exposed to ambient H_2O and CO_2 , showing that the Pr_2O_3 reacted with the atmosphere to form species with a higher specific volume.

Characterization using TGA/DTA, FT-IR, and XRD was performed on Pr₂O₃, Pr₆O₁₁, Pr(OH)₃ and Pr₂(CO₃)₃•8H₂O powders to compare and contrast the thermal decomposition mechanisms and gain insight into the aging processes of both Pr₂O₃ and Pr₆O₁₁. As discussed in literature reports, Pr₂O₃ readily adsorbs H₂O and/or CO₂ to form hydroxide, carbonate, or hydroxycarbonate phases. It is of interest to compare the hydration/carbonation effects of Pr₆O₁₁ (more stable cubic form of Pr-O) to Pr₂O₃ (less stable hexagonal form). Commercially available Pr₂O₃ and Pr₆O₁₁ were analyzed by XRD at several intervals over an 8 hour period of exposure to the ambient atmosphere. Visually, it is apparent that Pr₂O₃ had a much greater affinity towards the uptake of H₂O and CO₂ compared to Pr₆O₁₁. Figure 6 shows Pr₂O₃ expanding over the edge of the XRD sample holder while Pr₆O₁₁ remained intact unaffected by the presence of H₂O vapor and CO₂ during the aging study. Analysis by XRD confirmed that aged Pr₂O₃ contained large amounts of Pr(OH)₃ in addition to hexagonal Pr₂O₃. In contrast, Pr₆O₁₁ that contained only trace amounts of Pr(OH)₃ and was largely unaffected by exposure to atmospheric conditions. Analysis of Pr(OH)₃ and Pr₂(CO₃)₃•8H₂O was also performed to confirm the compositions of the commercial Pr-O compounds following exposure to the ambient atmosphere. While Pr(OH)₃ was not affected by exposure, Pr₂(CO₃)₃•8H₂O partially converted to Pr(CO₃)OH. The studies have provided insight into the rate at which Pr-O compounds will or will not convert to other species when exposed to atmospheric conditions. Unlike Pr₂O₃ and Pr₂(CO₃)₃•8H₂O, Pr(OH)₃ was not affected by exposure to H₂O or CO₂. So, once Pr species are in the hydroxide phase, they will not adsorb CO₂. Likewise, Pr₆O₁₁ is stable and did not react with ambient H₂O or CO₂.

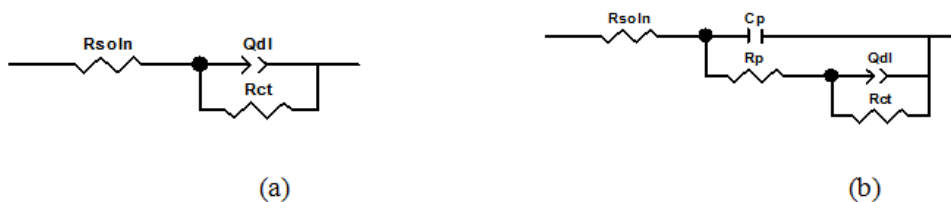
Figure 91. Equivalent circuits used to fit EIS data: (a) one time constant and (b) two time constants.

The EIS data were fitted to two different equivalent circuit models (Figure 91) to permit comparison to various physical characteristics of the coatings. The values of each of the components are listed in Table 19. Solution resistance, R_{soln} , was nearly constant in the range of 40-60 $\Omega\text{-cm}^2$ for all specimens. The bulk resistance of the coatings, R_p , which was also fairly constant at 70-100 $\Omega\text{-cm}^2$, is in parallel with the geometric capacitance of the coatings, C_p . Charge transfer resistance, R_{ct} , is related to the corrosion processes occurring at the metal-electrolyte interface in parallel with the constant phase element Q_{dl} . The increase in impedance due to exposure to humidity was caused by an increase in charge transfer resistance as this value increased from 5 to 94 $\text{k}\Omega\text{-cm}^2$ for as deposited coatings and 64 to 91 $\text{k}\Omega\text{-cm}^2$ for sealed coatings. Q_{dl} is an empirical impedance given by Equation IV above.

When n is greater than zero but less than 1, the system shows behavior attributable to surface heterogeneity or continuously distributed time constants for charge-transfer reactions. If n is equal to 1, Q_{dl} is a capacitor with $C = 1/Z_0$, which indicates the presence of a double layer at the electrolyte/surface interface of the substrate. If n is equal to 0, Q_{dl} is a resistor with $R = Z_0$. The value of n for all of the CeCCs was in the range of 0.65 to 0.79, which indicates a distribution of time constants in these specimens. The value of χ^2 is a measure of the model fit to experimental data as it is calculated from the sum of the squares of all residuals, with lower values indicating better fitting. The highest χ^2 value given by the ZSimpWin was 0.01, indicating very good agreement between the data and the equivalent circuit models.

A Bode phase diagram of as-deposited CeCCs showed slight inflection at $\sim 10^4$ Hz after the panels were subjected to the humid environment (Figure 92a). There was no significant difference in the Bode phase diagrams of sealed panels before and after exposure to humidity (Figure 92b). The presence of an inflection at $\sim 10^4$ Hz for as-deposited CeCCs indicates development of a new time constant. As-deposited CeCCs could be fitted to an equivalent circuit with only one time constant before exposure to the humid environment (Figure 91a). After exposure, as-deposited panels were fitted to an equivalent circuit with two time constants (Figure 91b), indicative of an impedance due to the coating itself as well as and the metal-electrolyte interface.

Table 20. Summary of values calculated to fit EIS data (Figure 99a) to equivalent circuit models (Figure 91) for bare Al 7075-T6.

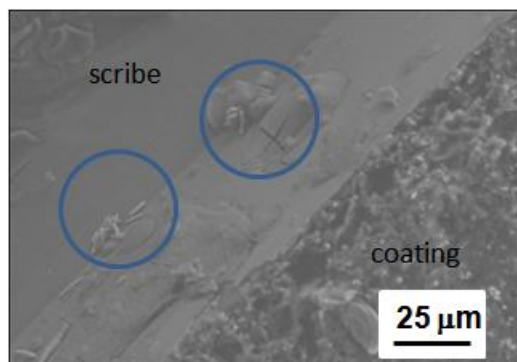
Figure 105. Micrograph of several clusters (denoted by circles) of Pr-rich precipitates found within the scribe of a water-based series panel following 1000 hours salt spray exposure.

Discrete Pr-rich areas were also found near the primer-scribe interface, which appeared to indicate that Pr-species were migrating out of the primer matrix and re-precipitating in the scribe (Figure 105).

Areas where Pr-precipitation products were found were also Cu rich, suggesting that the presence of Cu-containing intermetallic particles in the substrate influenced the precipitation of Pr. This may be an indication that Pr species were precipitating to passivate galvanic couples within the scribed areas. Work is in progress to identify the exact phase/composition of the Pr-precipitation products as well as to determine the growth mechanism within the scribe.
